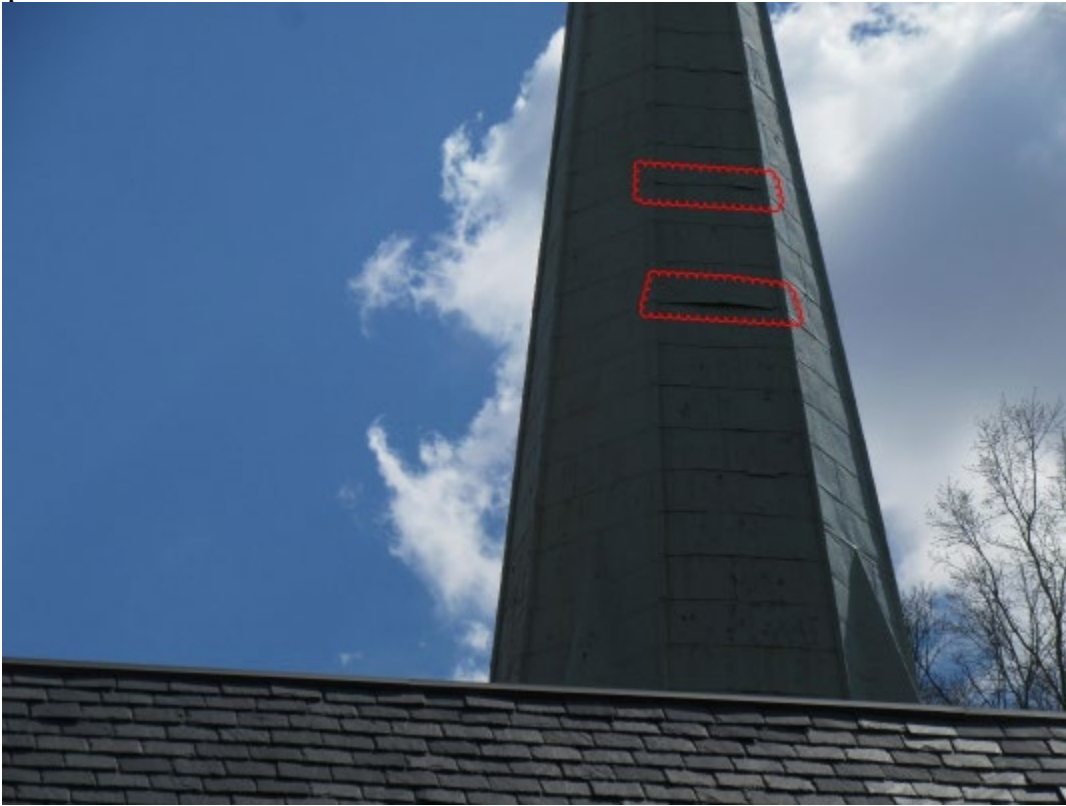
Bowed out pieces of metal on north side.

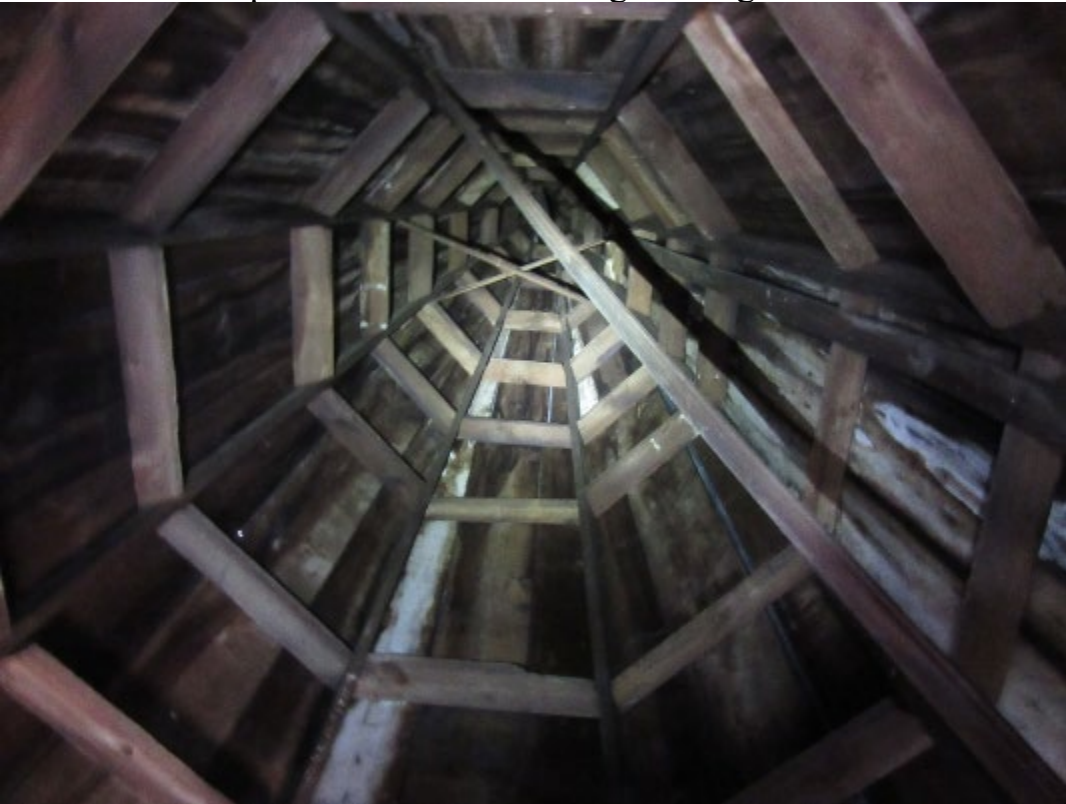
View up into wood-framed portion of tower showing framing and efflorescence on planking

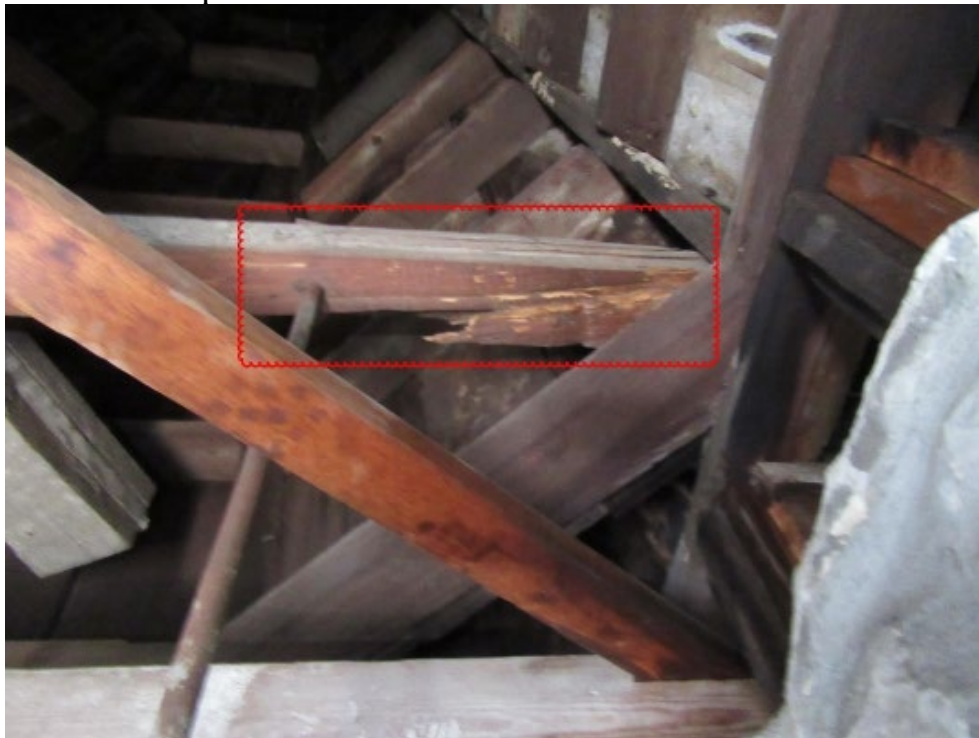
Cracked timber beam with partial loss of section

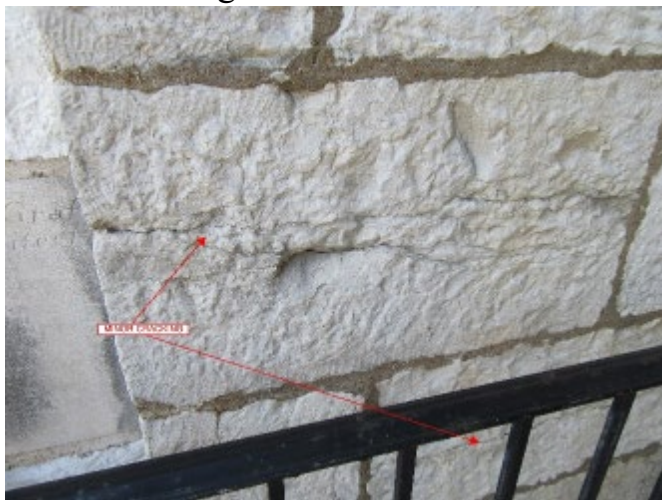
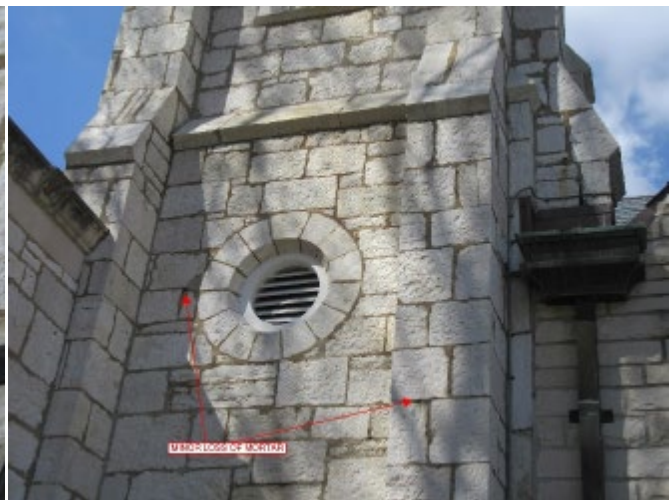
Minor cracking and mortar loss on exterior face of limestone walls
