**PHOTOS OF EMMANUEL BELL TOWER AND STEEPLE STRUCTURE IN NEED OF REPAIR  
JANUARY 2021**

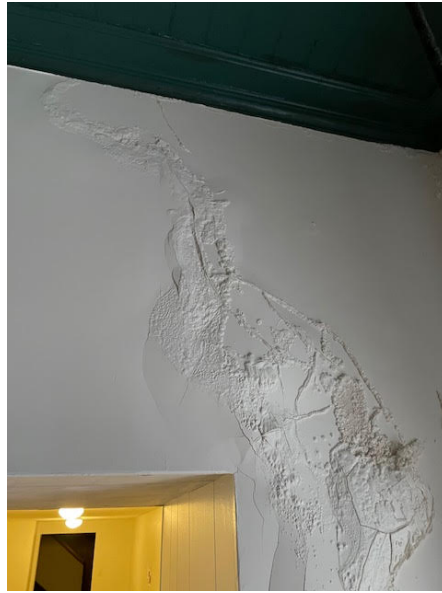
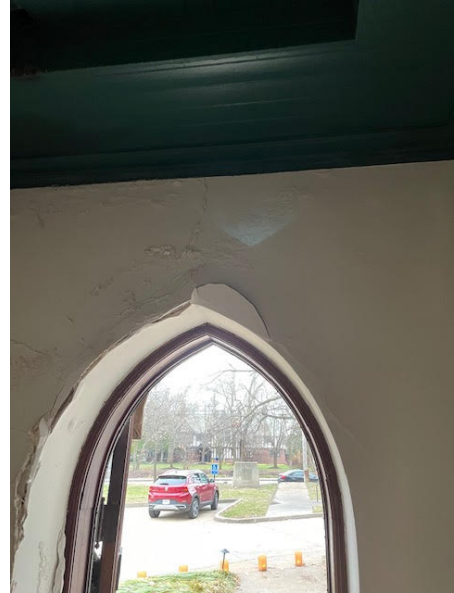
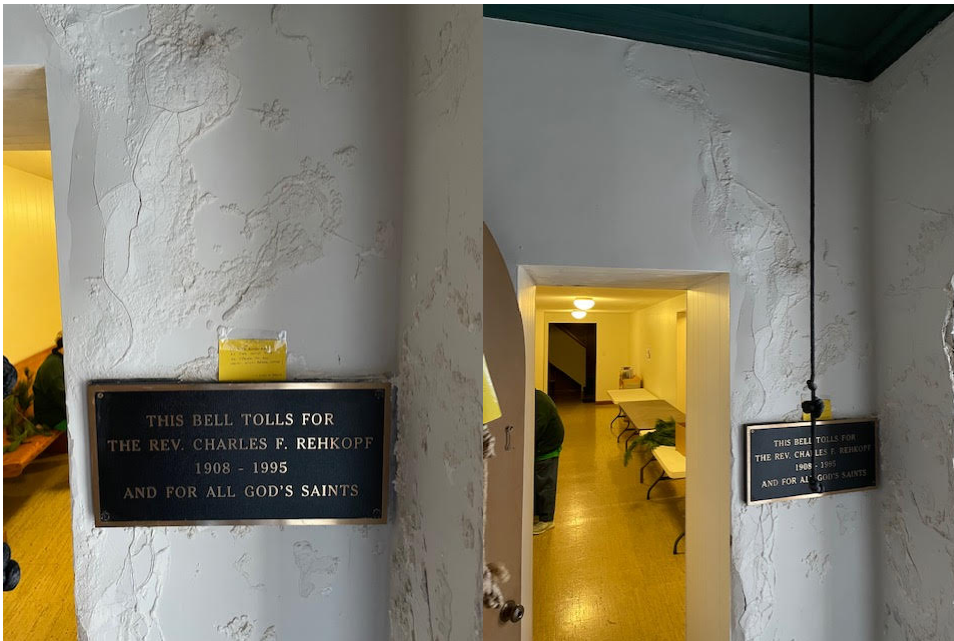
All the walls in the bell tower have water damage coming from water infiltrating the steeple exterior. Images of the east and south walls. The steeple is clad in terne metal.

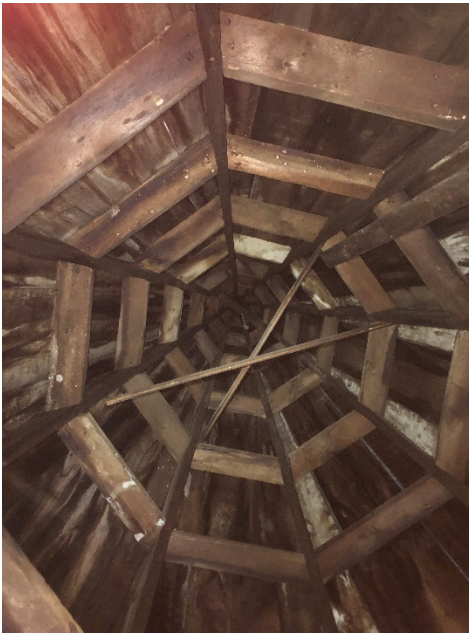
Left: Looking up into the steeple structure. Above the stone, the structure is entirely made of timber.

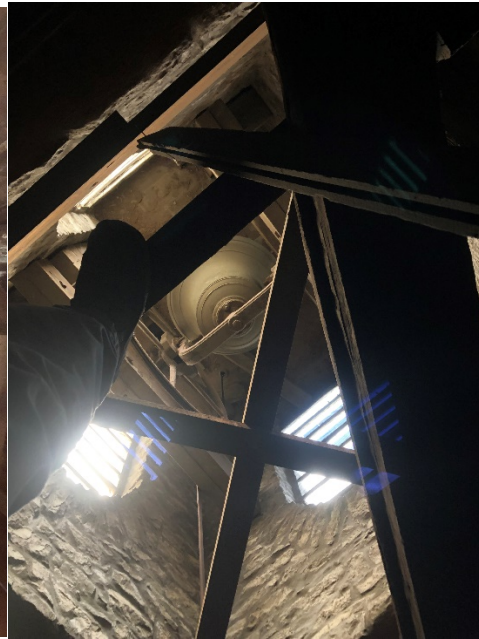
Right: Looking down from above the bell. The foot is Rick Kuhn who took many photos inside the steeple
